# WHY THE RED/GRAY CHIPS ARE NOT PRIMER PAINT

Niels Harrit, May 09

It has been suggested, that the red/grey chips discovered in the dust from the WTC collapse catastrophe<sup>1</sup> could originate from rust-inhibiting paint (primer paint) applied to the steel beams in the towers. This letter compares the elemental composition and the thermal stability of the two materials based on the description of the protective paint in the NIST report and observations on the red/grey chips.

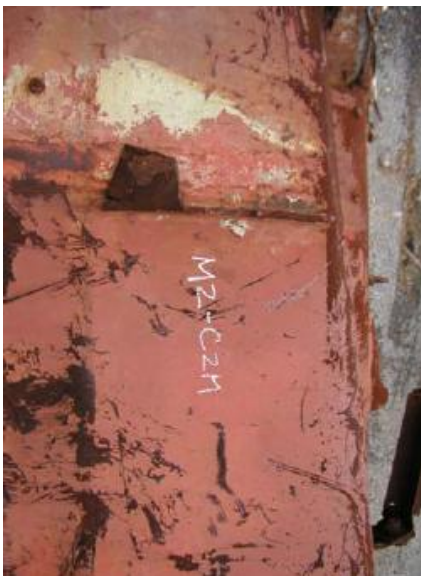
Figure 1. M2-C2M (WTC 1, Col.130, FI 98) from NCSTAR 1-3C appendix D<sup>2</sup>.

Examples of typical beams are shown in Figure 1 and Figure 2.

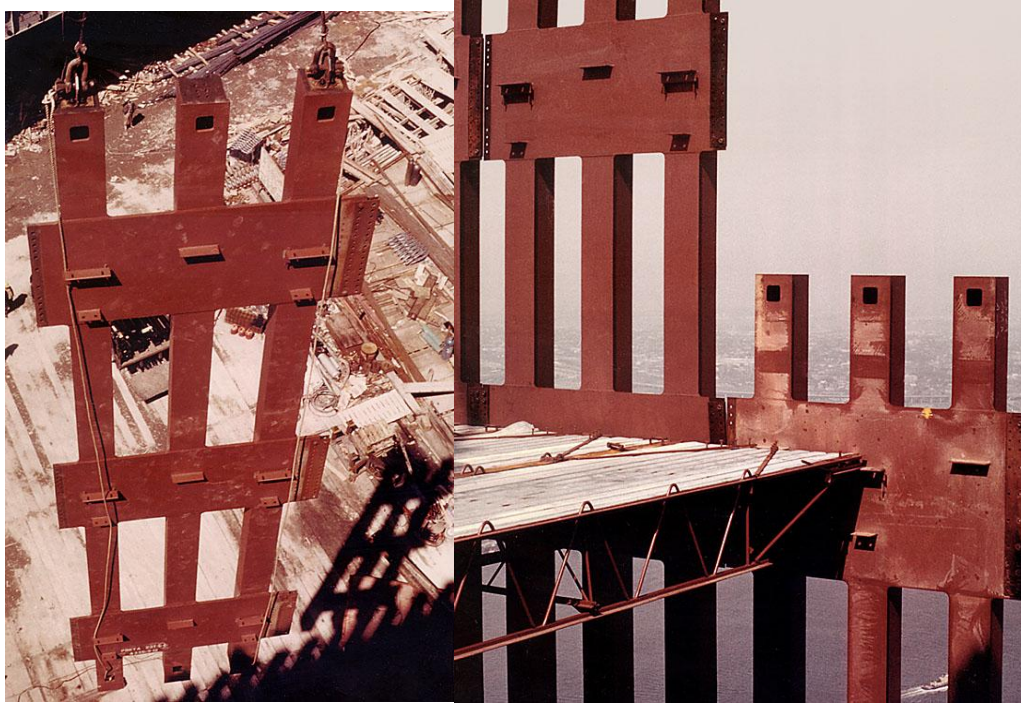
Figure 2. Perimeter columns in WTC towers. From NIST.

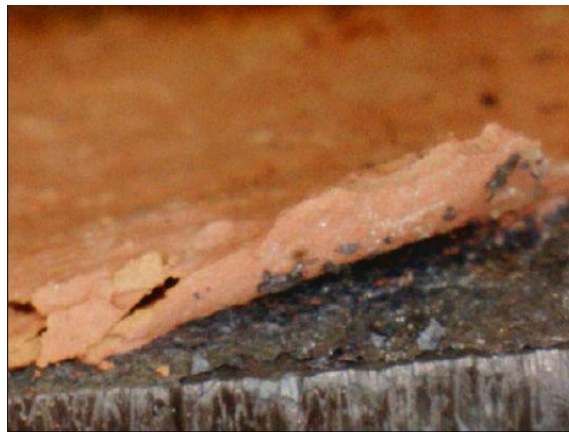
Source: NIST.  
Figure D-4. Formation of a black scale between paint and steel after exposure greater than 650 °C. Paint readily spalled.

Figure 8. From NCSTAR 1-3C appendix D<sup>2</sup> showing formation of a black layer under the primer paint at temperatures beyond 650 °C.

between the paint and the steel (Figure 8). NIST took the samples beyond 800 °C at which temperature the scale formation and peeling off of the paint from the steel was prevailing. One may hypothesize that formation of the black scales is due to charring of the organic binder.
